CASE STUDY THERMAL IMAGING

**FINDING ISSUES ON TERMINATIONS
BEFORE THEY FAIL MEANS:
HAPPY CUSTOMERS, LOWER COST AND
ENHANCED RELIABILITY FOR YOUR SYSTEM**

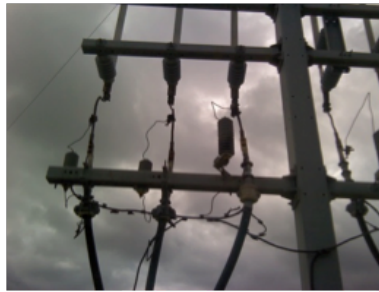
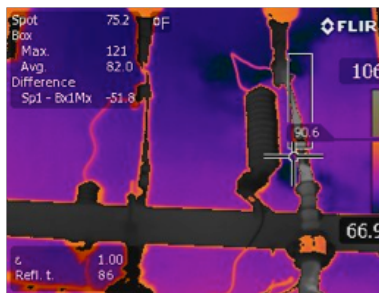
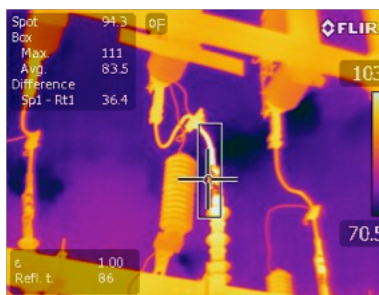
He used the thermal imaging equipment on one of Infratech's customer's systems, and found a temperature differential between two feeder terminations of 20.9°F. He knew that he not only had the perfect example for his thermography coursework, but also that the utility needed to be informed immediately.

The customer stated that the images clearly showed a "hot spot" at the terminator connection, and this overheating problem came from the bolts being over torqued beyond the 40ft lbs as specified in the Distribution Construction Standards manual.

The issue could be resolved prior to a failure by switching the section out (redistributing load) and replacing the terminators without a single moment of loss of service to any customers. The utility's customers were completely unaware of the repair. Our Supervisor received accolades from the instructor, but more importantly he and the utility got a first class demonstration of the benefits of thermal imaging.
