# CASE STUDY

## INFRATECH PREVENTS COSTLY OUTAGE BY CREATING A "SAFETY BARRIER"

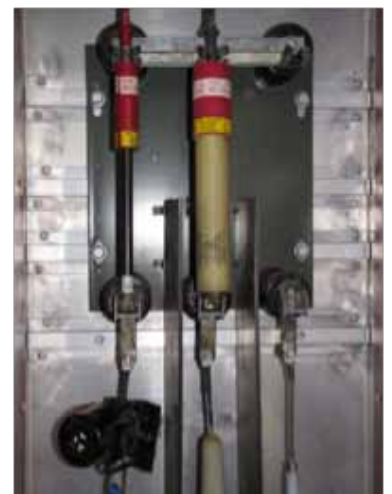
Together, we were able to design and successfully test two different sets of insulated covers that fit the different sizes and types of cabinets and switch gear used by our customer.

This allowed the team to measure and fit a prototype cover in the different applications of the cabinets and switch gears used. There was a lot of trial and error in designing and fitting the insulated cover. It was necessary to keep the number of pieces to a minimum to reduce assembly time on site and to prevent confusion in the correct placement of pieces in the different combinations of switches and cabinets.

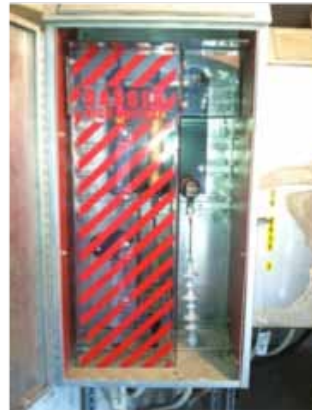
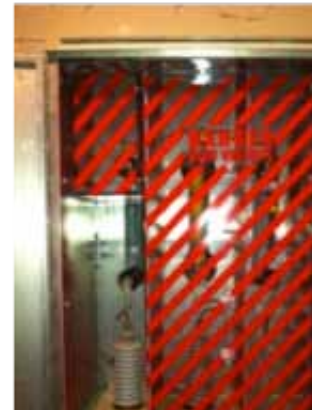
Images are of two different sets of Vault Switch Cabinet Cover; installed in two different cabinets with two different types of switch gear.

The Insulated Cover is made of 3/16" (177 mil) thick Makrolon GP Sheets of transparent Polycarbonate, having the dielectric properties listed below.

Dielectric Strength:      ASTM D149      V/mil      380  
(177 mil x 380 volts pre mil = 67,260 V)

The Team ended up with two kits containing numbered pieces stored in bags with separate compartments to keep pieces separate. This makes assembly an easy 1-2-3 process and prevents damage to the pieces because they don't touch.
