CASE STUDY

SUBAQUEOUS UTILITY CROSSING BENEATH BOCA CIEGA BAY, FLORIDA

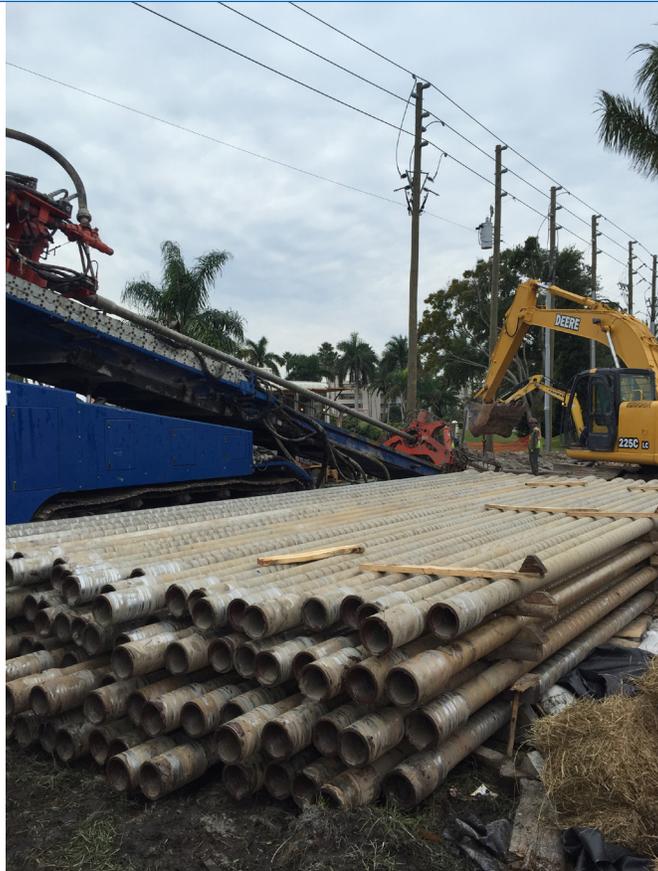
The bore was pre-reamed at 18”, 26” and 32” before the large 20” pipe could be fed into the bore tunnel.

Once the 20” pipe was in place, the the six 4” inner-ducts were pulled into the 20” casing and finally the copper cable into the

inner-duct. The bore and the pipe arrived right on target on the other side of the bay.
